NASA TN D-2222

SOUNDING ROCKET RELIABILITY REASSESSMENT

by Abrom Hisler Goddard Space Flight Center Greenbelt, Md.

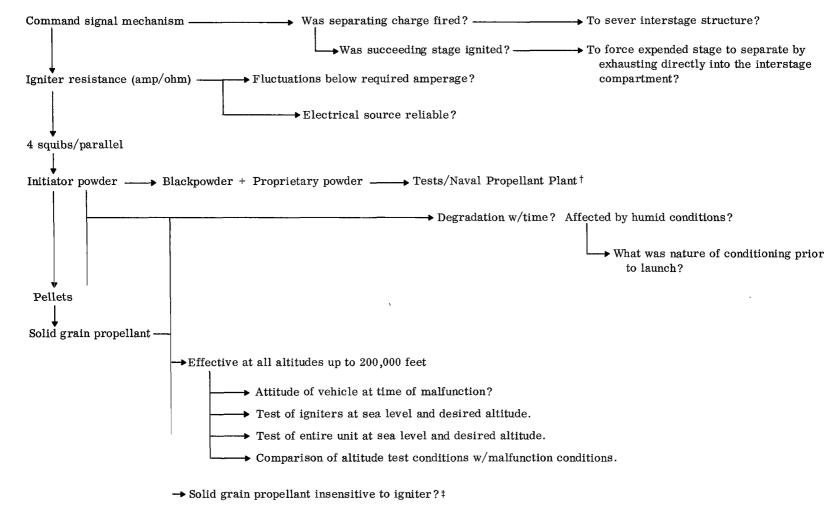
Sustainer Trouble-Shooting Layout

^{*}Discussion: The sequence of necessary events is shown on the extreme left starting with the operation of the command signal mechanism and ending with the sustained combustion of the solid grain propellant. Appropriate questions and applicable references for further study are inserted along this sequence in the attempt to identify the point at which the sequence was broken. In this particular case, in answer to the question "Was the separating charge fired?" the answer is "No" since the vehicle prematurely broke up before this stage of the sequence.
